Important Safety Notice Concerning SCOTT HUD Quick Disconnect Hoses

DATE: 29 August 2008

TO: All Users of SCOTT® AIR-PAK® 50, AIR-PAK 75, NxG2, and NxG7
Self-Contained Breathing Apparatus equipped with Heads-up Display (HUD)

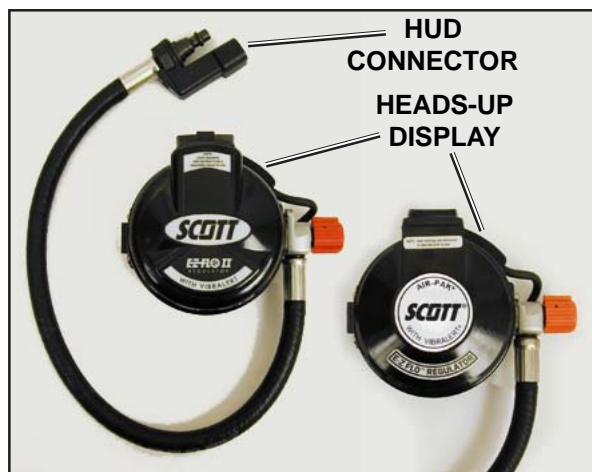
When equipped with a quick disconnect (QD), the low pressure hose to the facepiece mounted regulator on 2002 and 2007 Edition NFPA 1981 SCBA includes an electrical connector to energize the Heads-Up Display (HUD) along with the air connection. See FIGURE 1.

FIGURE 1 – HUD Facepiece Mounted Regulators with QD

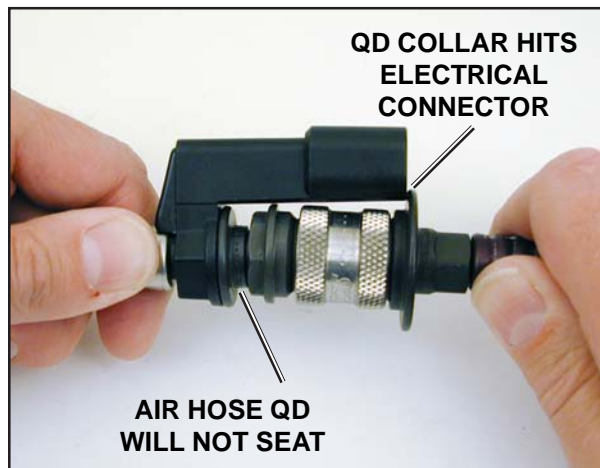
Changes to the length of the electrical connector between the 2002 and 2007 editions have resulted in clearance issues between the new connector and certain auxiliary hose fittings on SCOTT manufactured air sources in the field. See FIGURE 2.

**FIGURE 2 – Unacceptable Fit
UNMODIFIED LONG CONNECTOR**
(Note Interference Between Collar and Connector)

A corrective action was instituted to modify the new long connectors with a notch. But some hoses with the UNMODIFIED long connectors are in the field and must be replaced. Only the UNMODIFIED long connectors with NO NOTCH are subject to this safety notice.

Replacing the low pressure hose with one equipped a modified long connector will eliminate the potential clearance problem. This hose assembly will be made available at no charge to those users and will be provided to the authorized service center for installation.

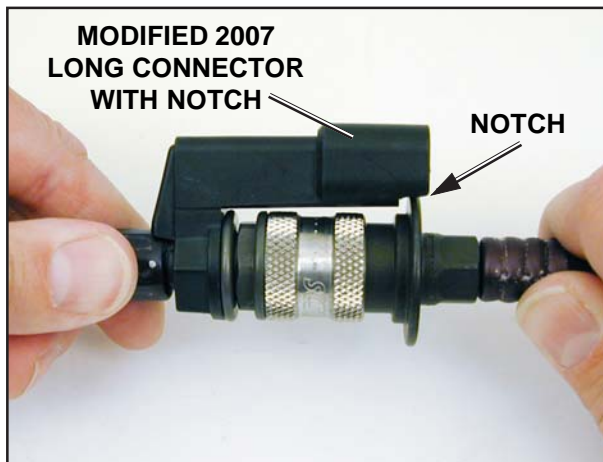
There is no fit problem with the long connector that has been modified with the notch or with the older short connector. See FIGURES 3A and 3B. The only fit problem occurs with the UNMODIFIED long connector.

**FIGURE 3A – Acceptable Fit
MODIFIED LONG CONNECTOR
WITH NOTCH**

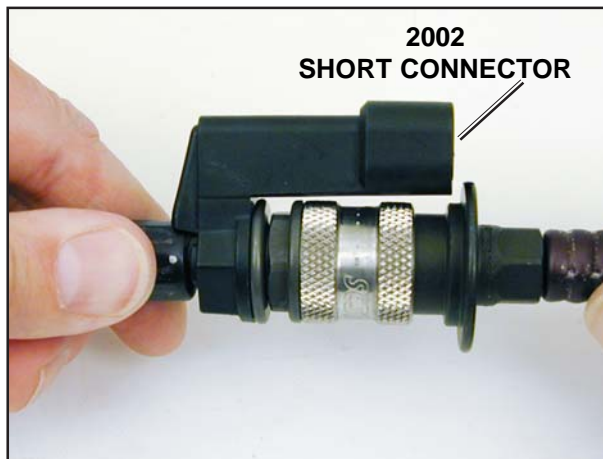
**FIGURE 3B – Acceptable Fit
SHORT CONNECTOR**

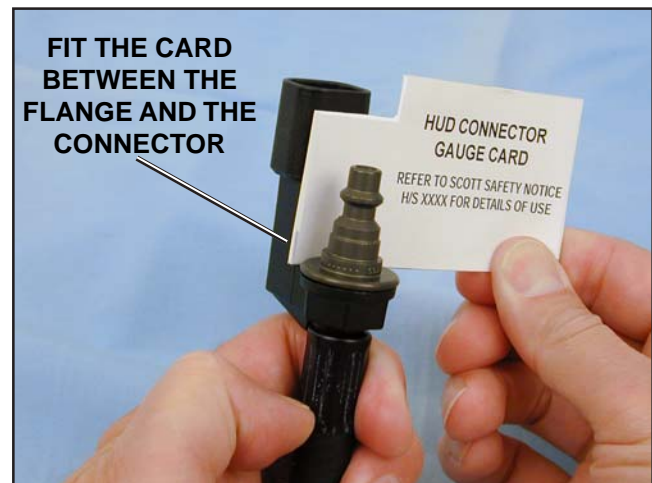
Hold the HUD CONNECTOR GAUGE CARD against the connector as shown in FIGURE 4. Be sure to fit the card between the flange and the connector body as shown.

FIGURE 4 – Positioning the GAUGE CARD

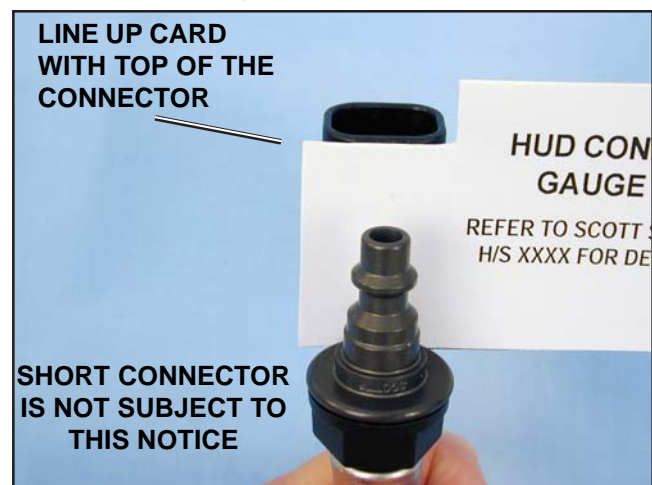
If the GAUGE CARD lines up with the top of the connector as shown in FIGURE 5, this low pressure hose is NOT subject to the notice.

**FIGURE 5 – GAUGE CARD
on Short Connector
NOT SUBJECT TO THIS NOTICE**

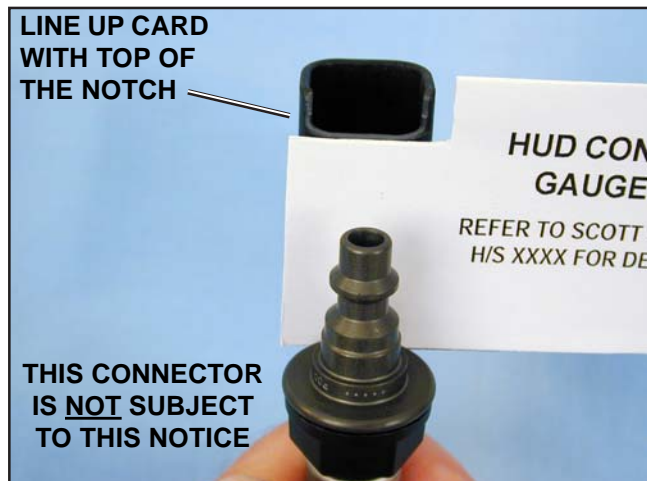
If the GAUGE CARD lines up with the NOTCH as shown in FIGURE 6, this low pressure hose is NOT subject to the notice.

**FIGURE 6 – Modified Long Connector with NOTCH
NOT SUBJECT TO THIS NOTICE**

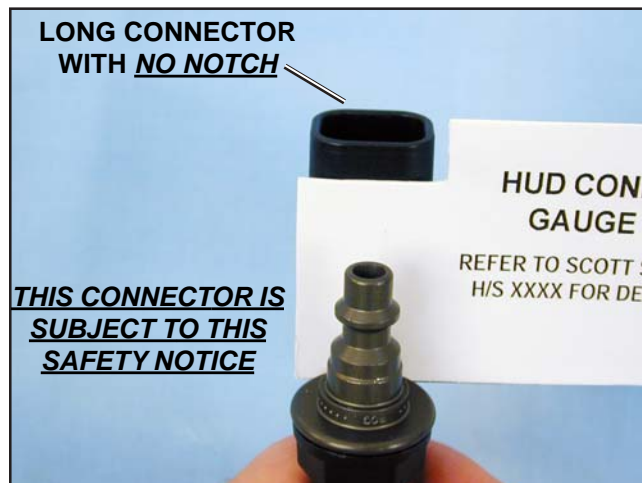
If the GAUGE CARD does not line up with either the top of the connector or with a NOTCH, you have found one of the UNMODIFIED LONG connectors. See FIGURE 7. **THIS LOW PRESSURE HOSE TO THE REGULATOR IS SUBJECT TO THIS NOTICE.**

**FIGURE 7 – UNMODIFIED Long Connector with NO NOTCH
ONLY THIS CONNECTOR IS SUBJECT TO THIS SAFETY NOTICE**

If you have a SCOTT Air-Pak 75 or NxG7 SCBA, have received replacement QD equipped low pressure hoses between October 1 and December 1, 2007 or have inspected the hose per these instructions and found you have any of the subject hoses (long connector with NO NOTCH), complete the attached card and forward it to SCOTT immediately. SCOTT will send the appropriate parts to your selected Service Center. The Service Center will contact you and make the necessary arrangements to install the parts on your SCBA.
